Coal Combustion Residue Impoundment Round 9 - Dam Assessment Report

Miller Steam Plant

Coal Combustion Residue Impoundment Dike Alabama Power Company West Jefferson, Alabama

Dewberry & Davis, LLC Fairfax, Virginia

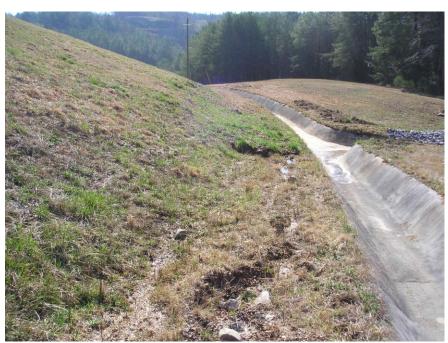
Stormwater runoff from the main dam outside slope is captured by a concrete lined ditch located along the abutments and toe of the slope. The drain discharges to a riprap lined ditch that empties into a creek in the woods beyond the toe of the dam embankment. Figures 5.2.3-3 and 5.2.3-4 show the concrete-lined ditch and the discharge drain, respectively.

Figure 5.2.3-3 Main Dam Surface Runoff Toe Drain Ditch

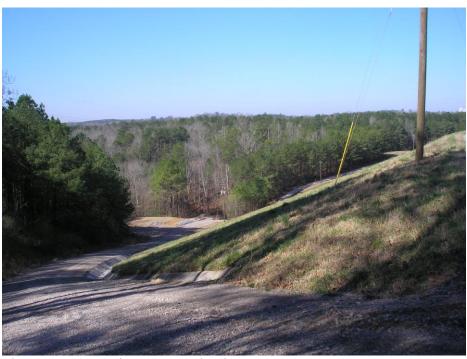
Figure 5.2.4-2 Main Dam South Abutment

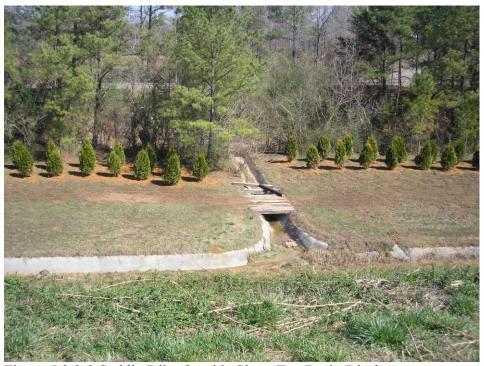
Stormwater runoff from the saddle dike outside slope is captured by a concrete lined ditch located along the abutments and toe of the slope. The drain is routed to a low laying area in the woods beyond the toe of the dam embankment. Figure 5.3.3-2 shows the discharge drain.

Figure 5.3.3-2 Saddle Dike Outside Slope Toe Drain Discharge

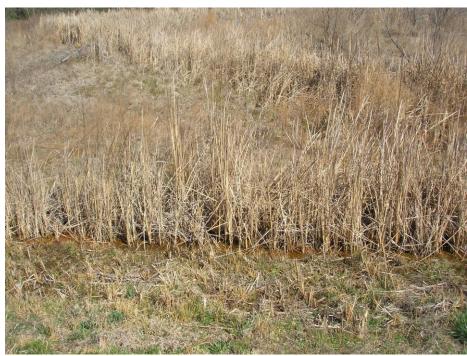
A small area of standing water was observed along the outside toe of the saddle dike. Figure 5.3.3-3 shows the observed wet area. Since the impoundment in the area of the saddle dike has been filled with ash it is expected that the observed wet area was the result of recent precipitation events.

Figure 5.3.3-3 Small Wet Area Along Outside Toe of Saddle Dike

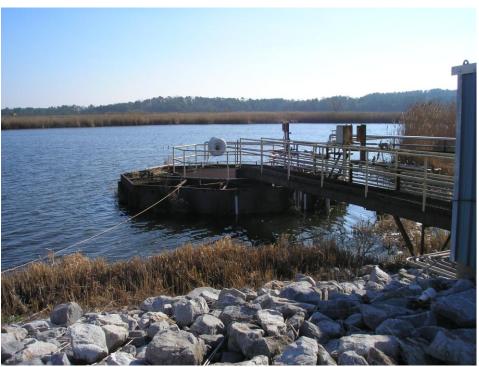
The impoundment overflow structure is located along the eastern side of the impoundment near the north abutment of the main dam. The CCR impoundment overflow structure consists of a concrete decant riser approximately 8 feet in diameter with an overflow elevation of about 420 Ft. and an invert elevation of 400 ft. The riser discharges to a 96-inch concrete pipe spillway located in natural ground beneath the south abutment of the main dike. The spillway discharges into an excavated drainage ditch that flows to the Locust Fork of the Warrior River. Access to the decant riser is provided by a fixed, steel frame, steel grate walkway. Figure 5.4.1-1 shows the overflow structure.

Figure 5.4.1-1 CCR Impoundment Overflow Structure

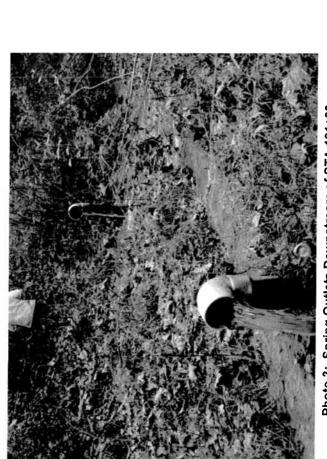
Photo 3: Spring Outlets Downstream of STA 121+00

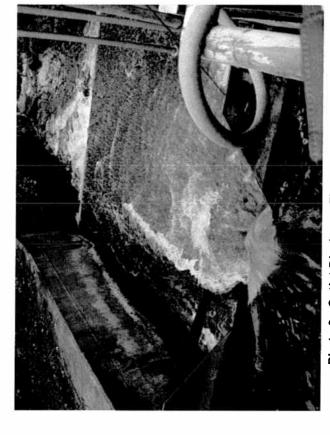
The inspection team then observed the discharge structure at 96+18 of the main dam. There was flow through the structure at the time of the inspection (Photos 7 and 8). No problems were noted at either the inlet or the outlet. Following the observation of the discharge structure, the crest of the dam was inspected. The wide crest road and the upstream riprap were observed to be in excellent condition. Vegetation was observed in portions of the riprap (Photo 9). It is recommended that this vegetation be removed by spraying.

Photo 8: Outlet Discharge Flow, Looking Downstream

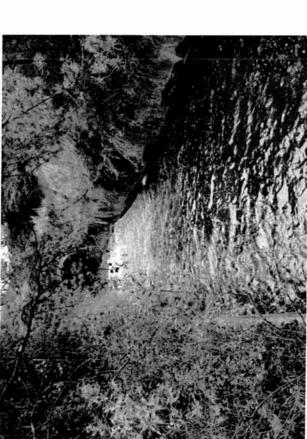
Photo 7: Outlet Discharge from Ash Pond

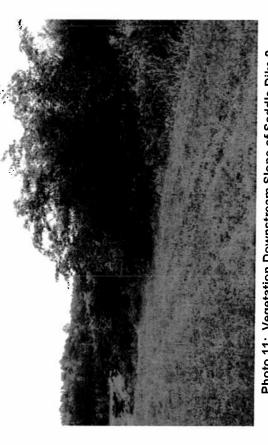
The saddle dam adjacent to Porter Road (northeast of the main dam) was also inspected. Operations have resulted in most of the pond in the area being filled with ash. The saddle dam appears to be performing adequately, but dense vegetation and trees were observed on the downstream face of the dike (Photos 10 and 11).

Photo 11: Vegetation Downstream Slope of Saddle Dike 2

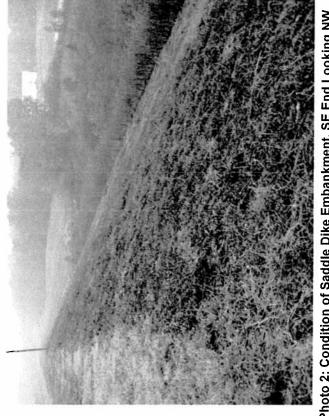
Photo 2: Condition of Saddle Dike Embankment, SE End Looking NW

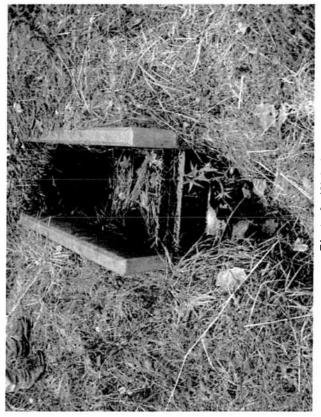
Photo 6: Weir 1

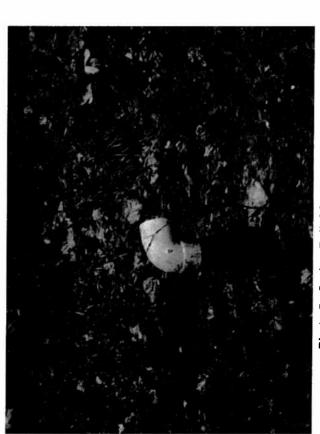
Photo 5: Spring Relief System Drain

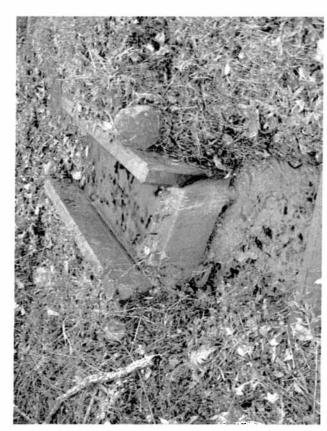
Photo 7: Weir 2

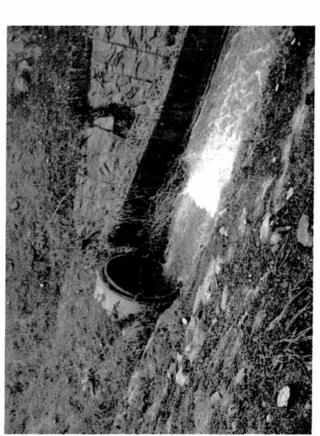
Photo 9: Outlet Discharge from Ash Pond

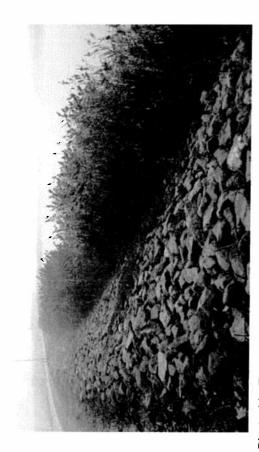
Photo 11: Typical Condition of Upstream Slope of Ash Pond Embankment

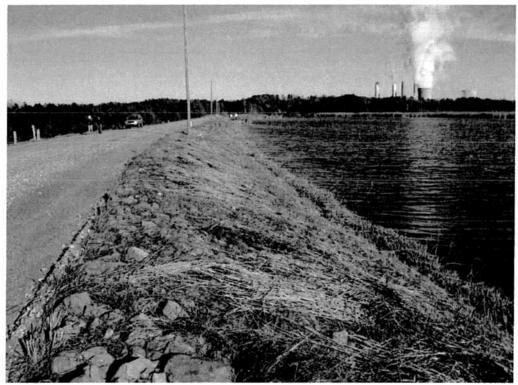
The inspection of the main ash pond dam started along the dam crest. The roadway along the crest was in excellent condition, and the embankments appeared to be very well maintained along both upstream (see Photo #1) and downstream (see Photo #2) faces. Also worthy of note is the effort taken to keep vegetation clear from the interface between the embankment upstream face and the pond waterline. *It is recommended that this level of embankment maintenance (on both the upstream and downstream slopes) be continued.* The downstream toe of the dike was inspected starting along the southern edge of the embankment near Station 125+00. This portion of the dam is the maximum height section. As was noted from the crest, the embankment vegetation appeared to be well-maintained and the concrete lined toe ditch was reasonably clear (see Photo #3). Along the toe of the embankment in this area, the plant emergency filter material stockpile was noted (see Photo #4).

Photo 1: Upstream Face of Main Ash Pond Dam

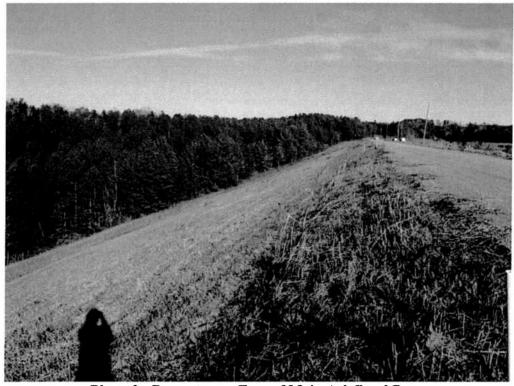
Photo 2: Downstream Face of Main Ash Pond Dam

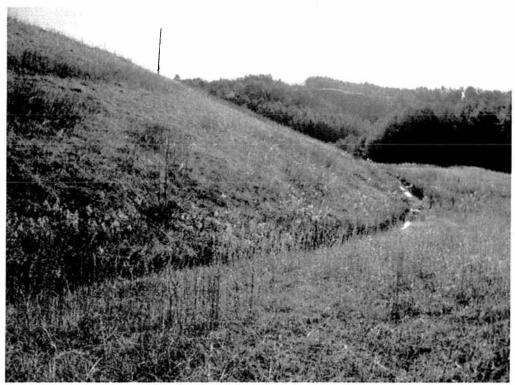
Photo 3: Typical Condition of Downstream Toe of Main Ash Pond Dam

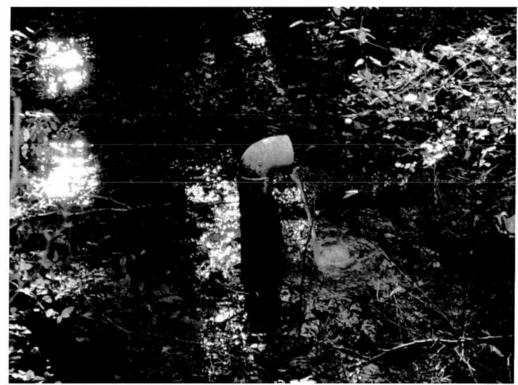
The spring drainage system installed downstream of Station 121+00 was inspected, and no problems were noted. The outlets were in good condition and flowing freely (see Photo #5). The area around the outlets was maintained and free of brush. Based on a review of photographs from previous inspections, the flow through the outlets appeared to be similar.

Photo 5: Spring Relief Drain Outlet Downstream of Main Ash Pond Dam

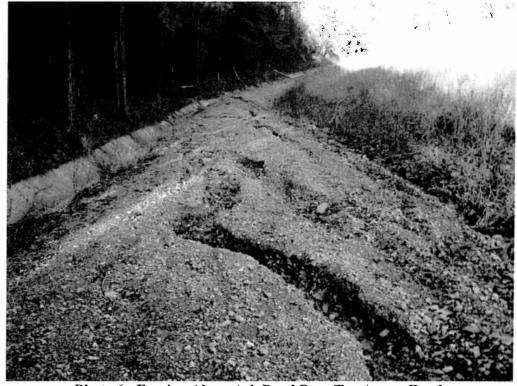
As a result of concentrated surface flows, significant rilling of the embankment toe access road was observed (see Photo #6). At the time of the inspection, it was recommended that the rilling be repaired to maintain the access for inspection, and it is the inspection team's understanding that this work has been completed. It is recommended that future surface erosion of the access road be repaired as it is noted during the plant's regular dam safety inspections.

Photo 6: Erosion Along Ash Pond Dam Toe Access Road

- The current level of embankment vegetation maintenance at the main ash pond dam should be maintained.
- Surface erosion to the ash pond embankment toe access road should be repaired as it is noted in the plant's regular dam safety inspections.
- Even though the filling of the pond in the area of the saddle dike has most likely reduced the loading on the structure, it is recommended that the saddle dike continue to be inspected and the vegetation on the embankment continue to be controlled.

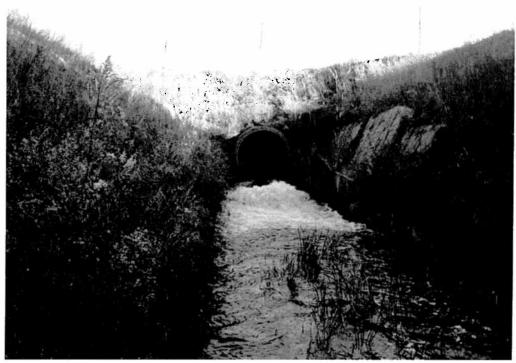
The discharge inlet and outlet structures were inspected (outlet on Photo #10), and no problems were noted.

Photo 10: Discharge Outlet Structure

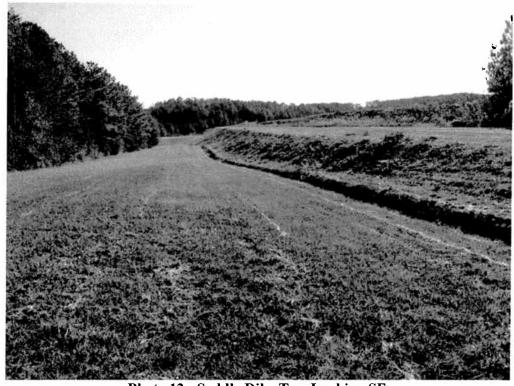
Photo 12: Saddle Dike Toe, Looking SE

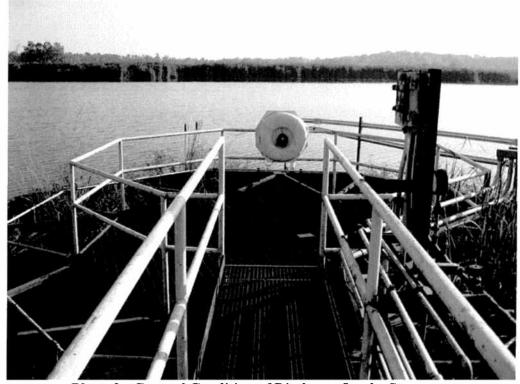
The discharge intake structure (see Photo #2) was inspected, and no problems were noted.

Photo 2: General Condition of Discharge Intake Structure

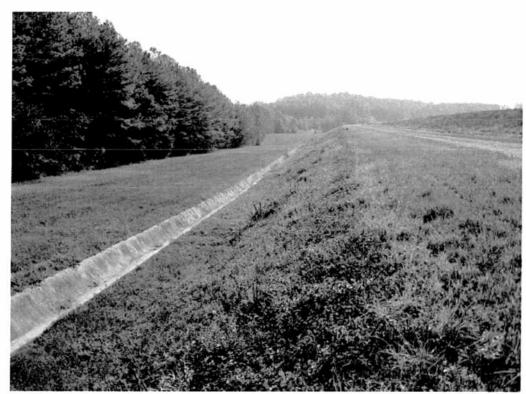
The saddle dike adjacent to Porter Road was inspected, starting at the southeastern end and moving to the northwest. As has been mentioned in past reports, the operations at the plant have resulted in most of the pond in the area being filled with ash, so the loading on the saddle dam as a water-retaining structure is likely reduced. At the time of the 2010 inspection the embankment appeared to be in excellent condition (see Photo #7). It is recommended that this level of embankment maintenance be maintained at the saddle dike.

Photo 7: Condition of Saddle Dam, Typical
